**ACTIVITIES ASSESSMENT of ACTIVITIES DONE IN
BOMBAY HOUSE –
ACTIVITIES AND THEIR LOCATIONS – JAN - JULY 2018**

SAVANI HERITAGE CONSERVATION PVT.LTD.
(Formerly known as SAVANI CONSTRUCTION CO. PVT. LTD.)

ACTIVITIES ASSESSMENT of ACTIVITIES DONE IN BOMBAY HOUSE

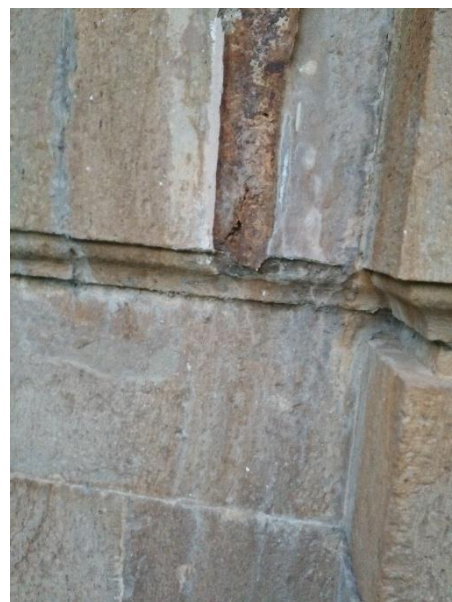
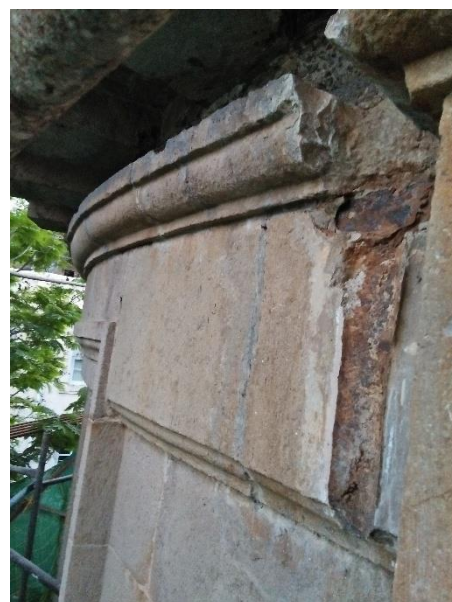
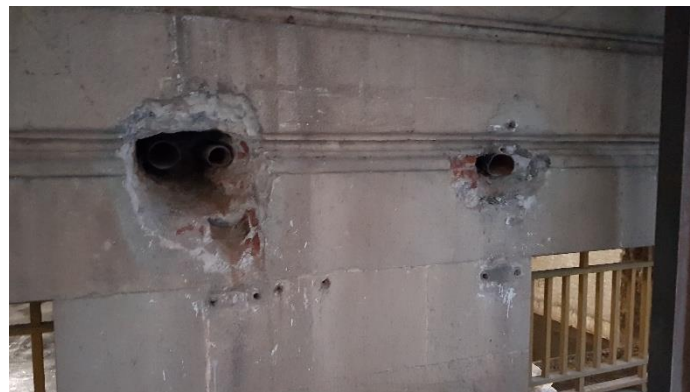
(Note: The stone surfaces on the external facades exhibit stone staining and accumulation of pollutants and sulphate stains in passage of time, more so, if the facades are not periodically maintained)

- The requires gently cleaning for which water misting and water washing with mild surfactants is generally recommended
- For stringer courses, cornices, capitals, etc. ammoniacal poulticing is employed
- Most surfaces along the external facades will be given gentle water washing using an intermittent fine spray of water to loosen the accumulated dirt and dust particles and this will be done using a fine nozzle sprinkling system that is regulated to spray a fine mist along the surface
